OFFICE OF MAINTENANCE AND OPERATIONS

DATE: January 16, 2014

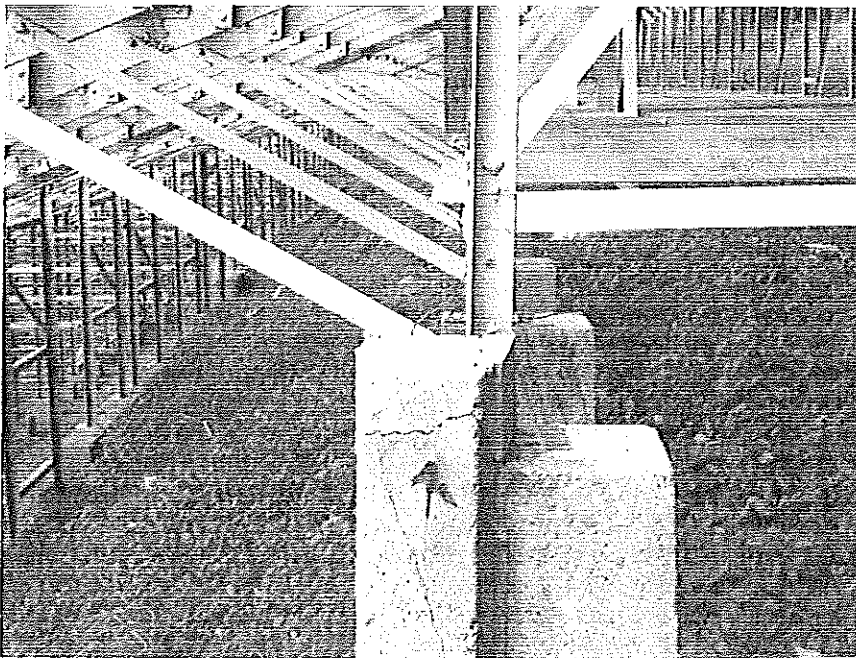
Photo 6: Visitor's Bleacher – Concrete Cracking at Previous Pedestal Repair

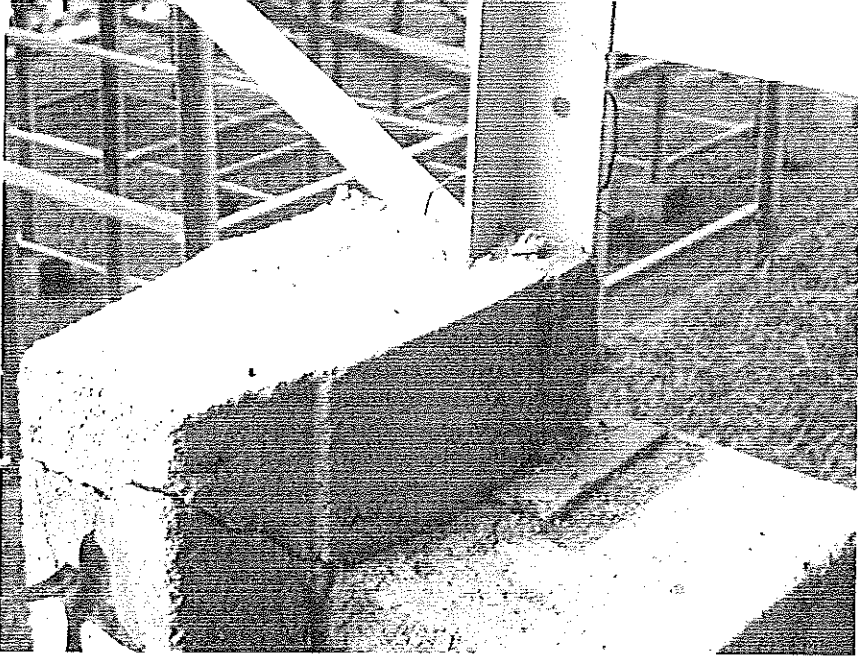
Photo 7: Visitor's Bleacher – Concrete Cracking at Previous Pedestal Repair

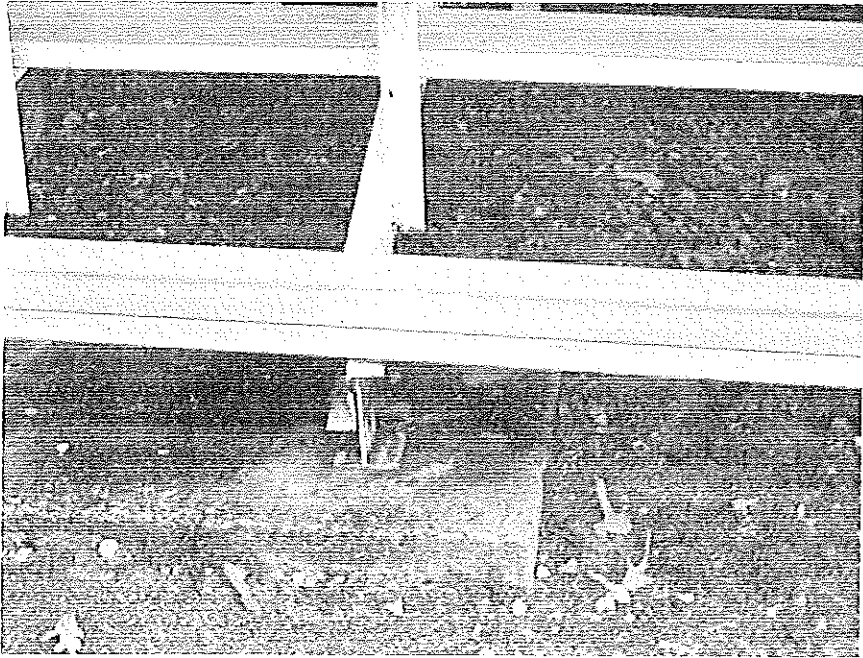
Photo 8: Visitor's Bleacher – Stringer Bearing Condition

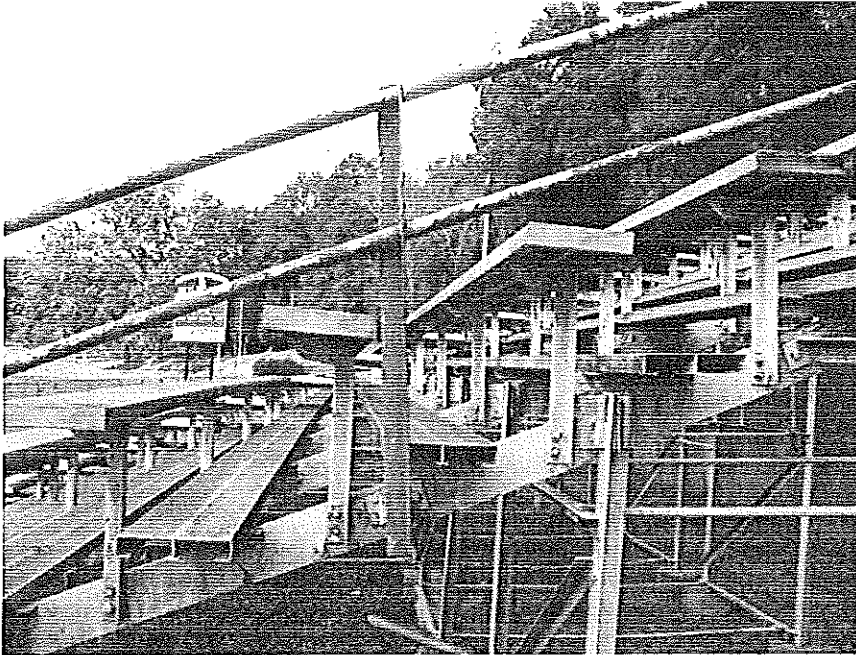
Photo 9: Visitor's Bleacher – Side Guardrail Condition

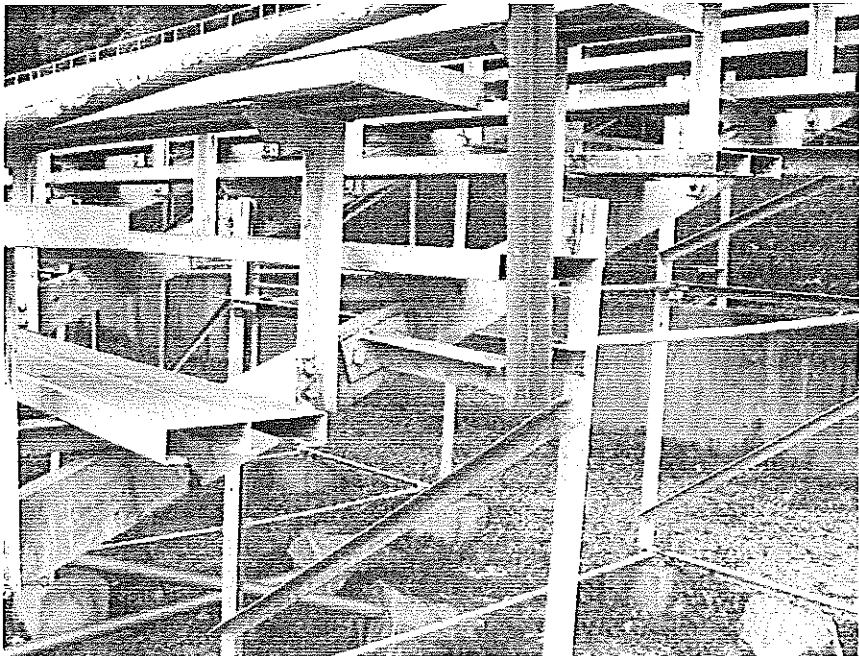
Photo 10: Visitor's Bleachers – Side Guardrail

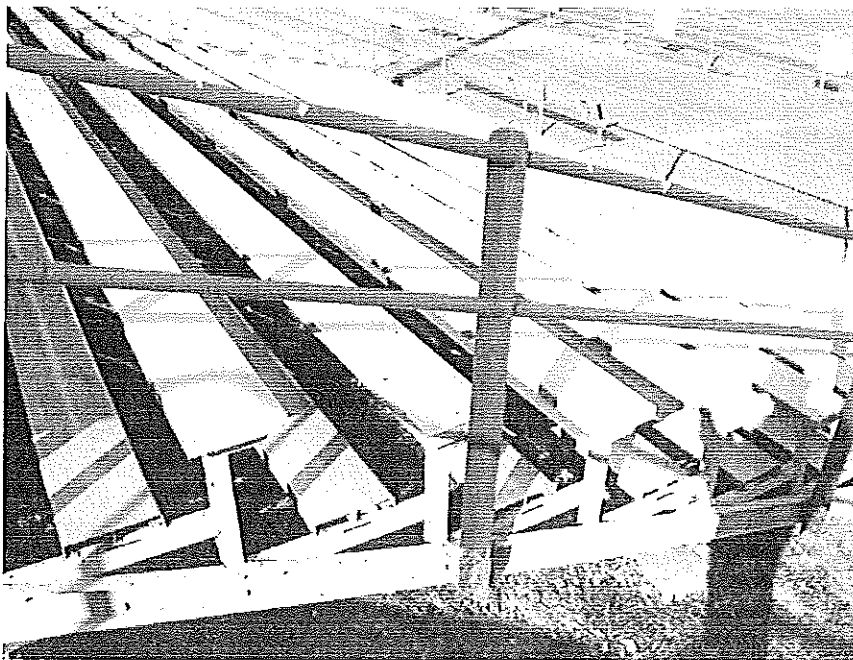
Photo 18: Home Side Metal Bleachers – Handrail Condition

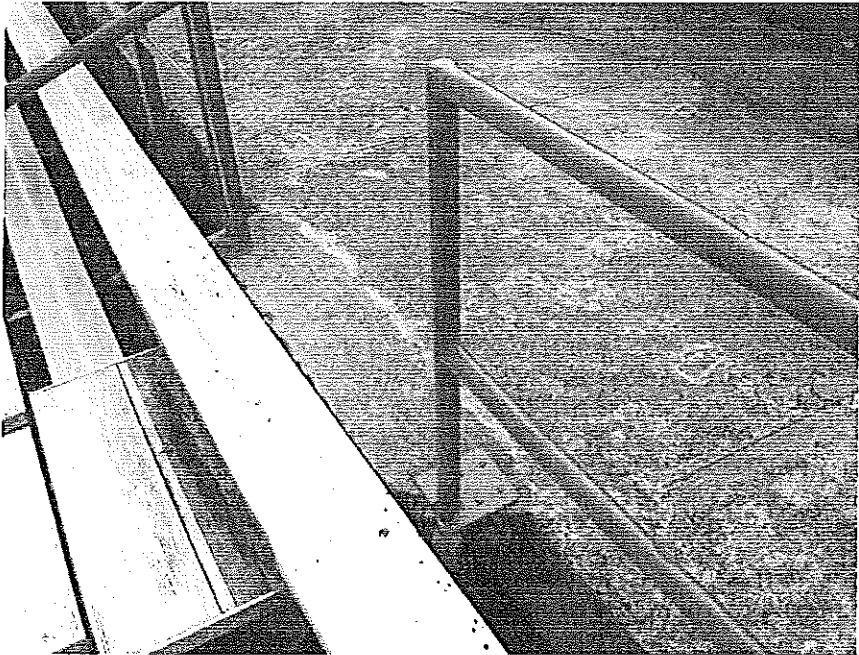
Photo 21: Home Side Metal Bleachers – Cracked/Spalled Concrete at Handrail Connection

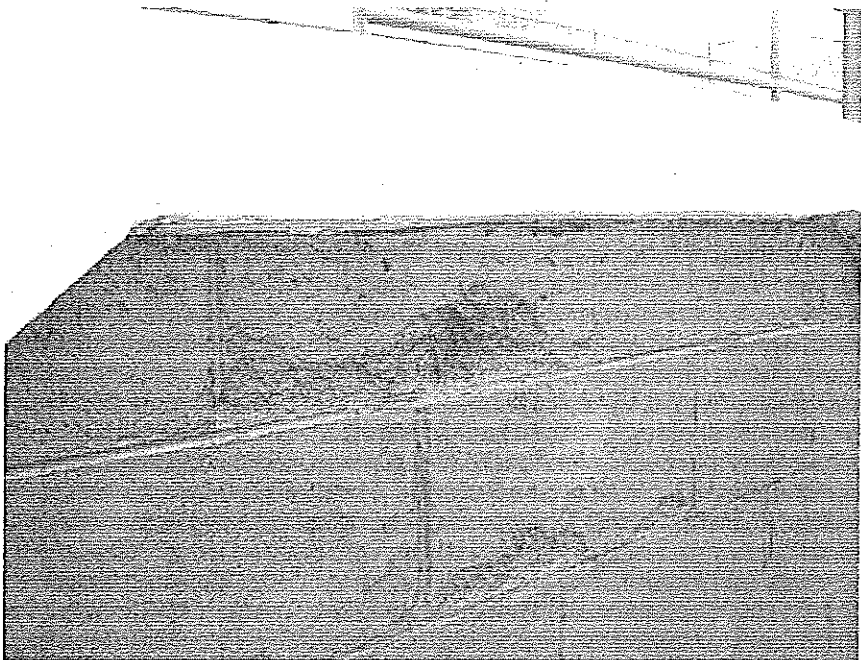
Photo 22: Home Side Stands – Deterioration at CMU Foundation Wall

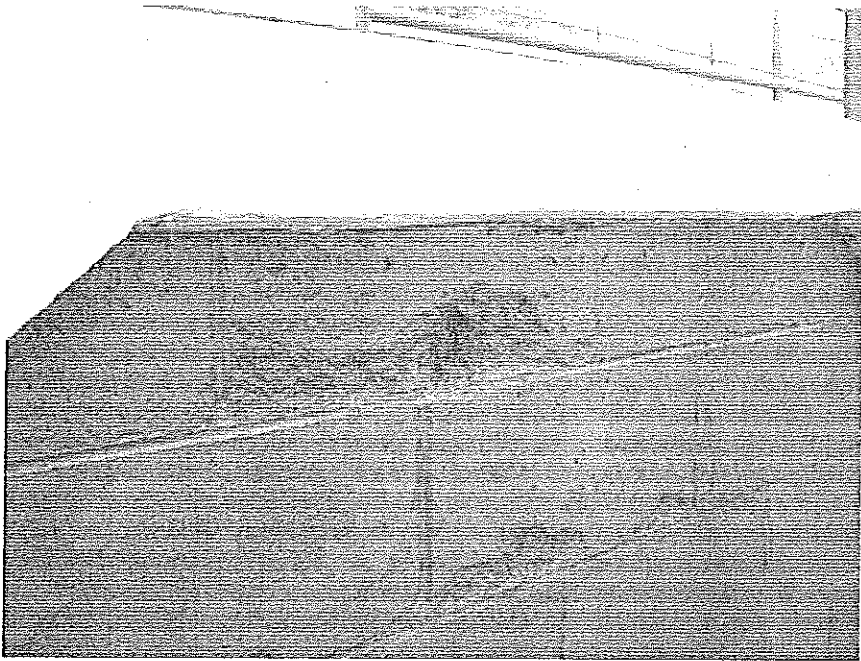
Photo 23: Home Side – Deterioration at CMU Foundation Wall

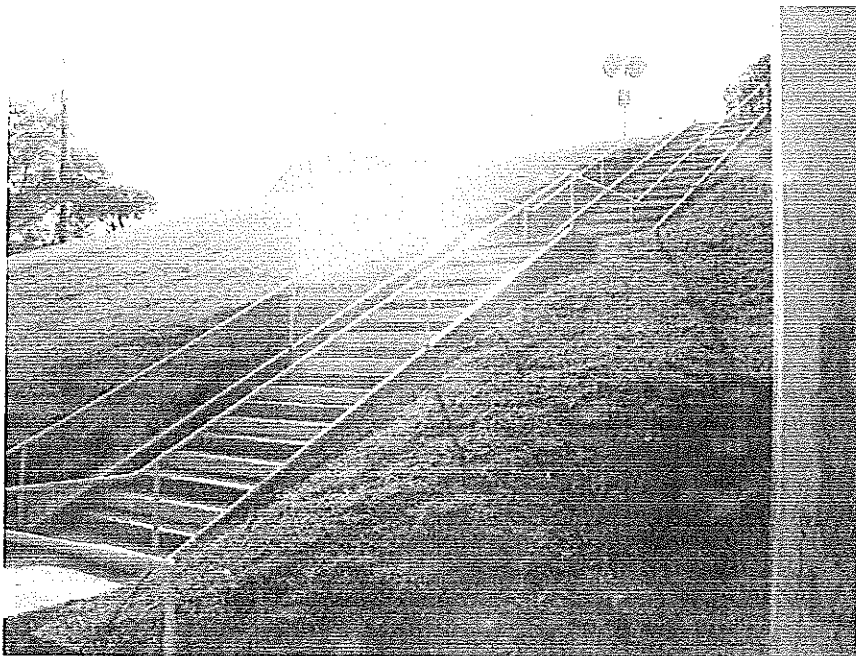
Photo 24: Wildcat Crossing Stair on Grade

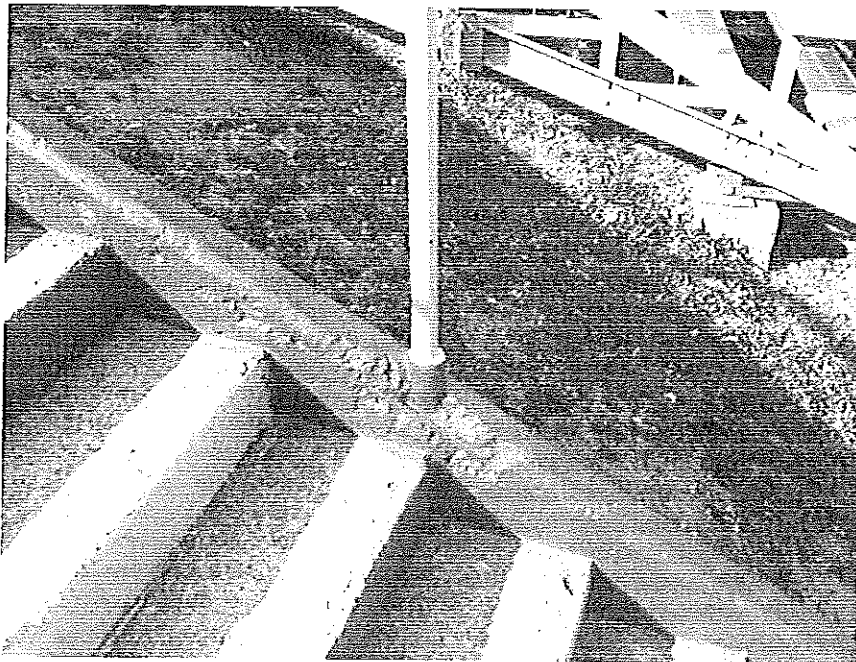
Photo 26: Wildcat Stair – Concrete Spalling/Exposed Rebar

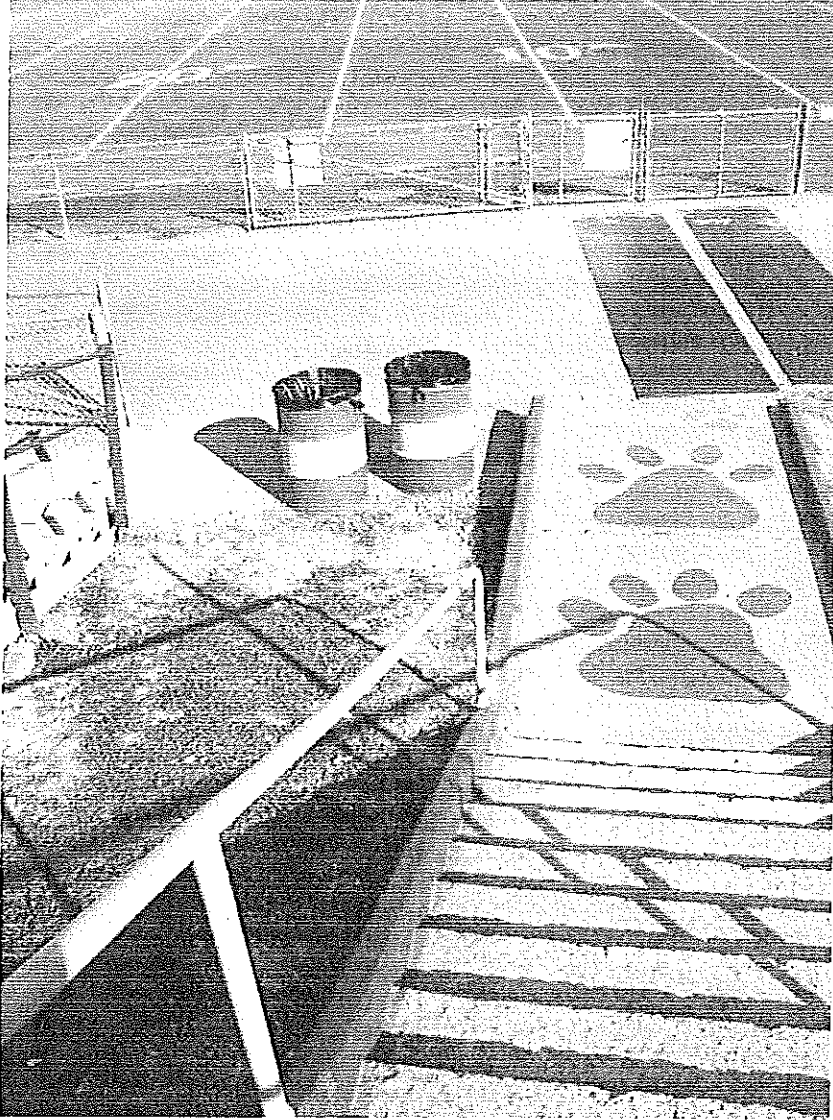
Photo 27: Wildcat Stair – Long Span between Handrail Posts
